New Insights on the Sinking of MV Estonia

ABSTRACT

MV Estonia, Forensic Study, Damaged Ship Stability, Time to Capsize

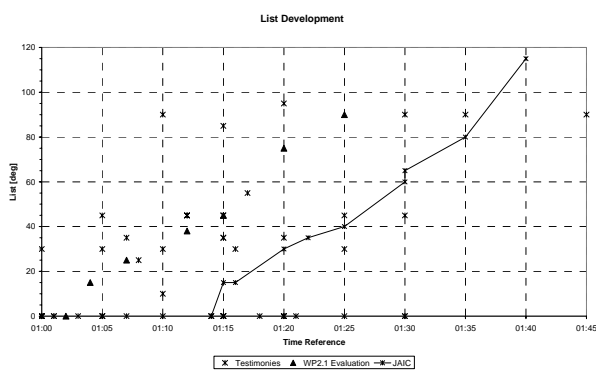
Most survivors state that the vessel heeled substantially, see Figure 1. Many persons onboard have not managed to escape, and hence, quite likely, considerable heeling developed rapidly, within a few minutes from an initiating event and thus prevented persons to abandon the ship.

Figure 1 The process of heeling as reported by witnesses. Established by Rutgersson *et al.*, [3].

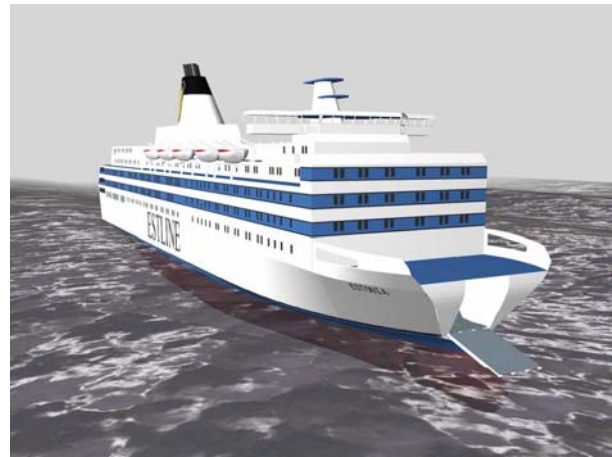
The explanation of the cause of the heeling offered to date is the water on deck, reaching the car deck through open bow doors, see Figure 2.

Figure 2 The primary JAIC hypothesis of the loss of the vessel is the detachment of the bow visor, and subsequent ingress of floodwater onto the car deck through a partially opened ramp.

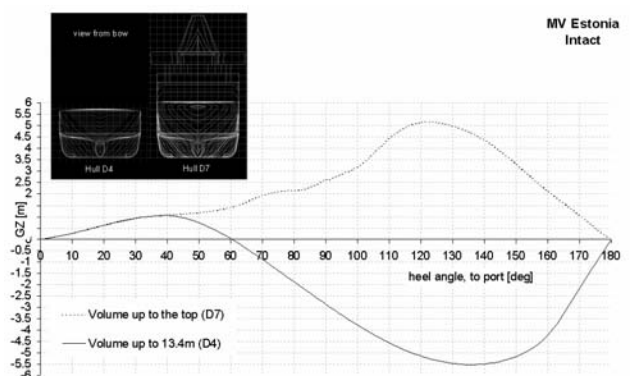
A visual picture taken by one of the survivors clearly demonstrates the ship at over 90 deg angle of heel. Therefore, the vessel capsized, that is she heeled beyond some 40deg, at which attitude the restoring capacity of the ship's watertight enclosure reaches its maximum, see Figure 3. Theoretically, once the vessel heels to this angle, capsizing becomes imminent.

Figure 3 GZ curve for MV Estonia, when buoyancy is considered to either, top of the car deck (D4) or tip of the funnel (D7). The latter, obviously hypothetical, is shown to visualise the physics of the real capsizing process ignored in typical routine ship stability calculations. Loss of the buoyancy above D4 must take some time.

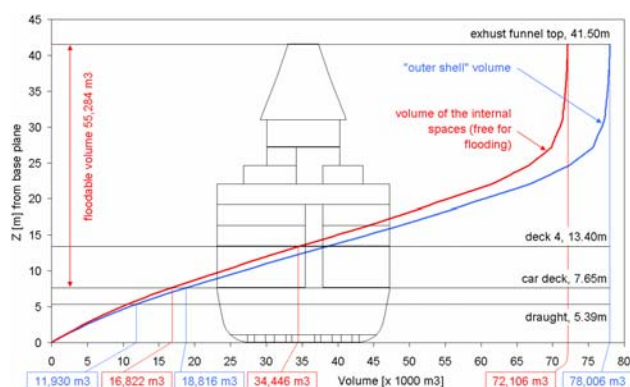
As is shown in Figure 5 below, for the MV Estonia to sink, flooding must amount to at least **10,792 m³** in the spaces below the car deck, in addition to complete flooding of all other spaces on the ship. In case of any air pockets remaining in any space from the car deck upwards, the flooding below would have to be higher, proportional to the volume of these air pockets.

Figure 5 The whole “body” of the MV Estonia would displace 78,006 m³ of water if fully submerged. The volume that could flood internal spaces from the car deck upwards to the tip of the funnel is 55,284 m³. The ship’s weight at the time of her loss would displace 11,930 m³. Therefore, the minimum amount of floodwater required to ingress below the car deck spaces for the ship to sink is: **10,792 m³** = 78,006 m³ – 55,284 m³ – 11,930 m³, or **64%** of all the floodable space below the car deck.

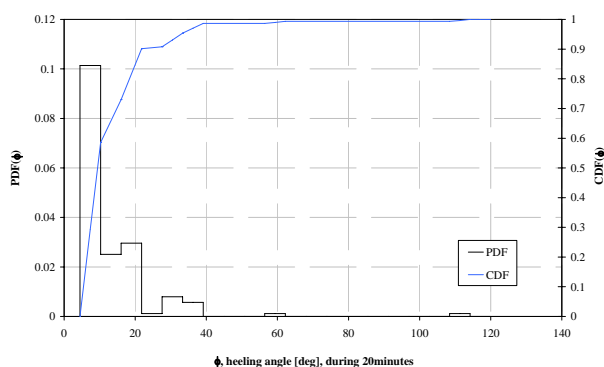
Figure 10 Probability distribution for heel angles recorded during the first 20 minutes from hull breach. Angles in excess of some 20deg result from up-flooding the car deck.

It is evident from this study, as performed to date, that angles of heel in excess of some 20deg could not result from flooding of the spaces below the car deck alone. The car deck (CD) must have also flooded.

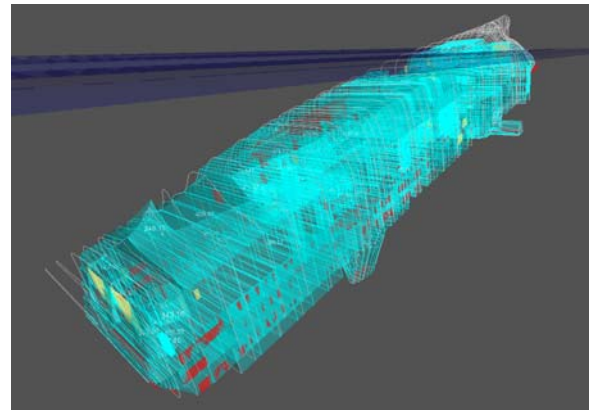
It would appear that the most likely damage, given the above assumptions, would be a 2-compartment flooding in the aft, where the machinery is located.

A sample simulation of one of the damages possible at this location is shown in Figure 12. It seems that at least qualitatively, the mode of the loss conforms to some rather established facts, such as sinking with the stern first.

Figure 12 Capsize and sinking of MV Estonia after flooding through damage in the way of engine room and car deck.

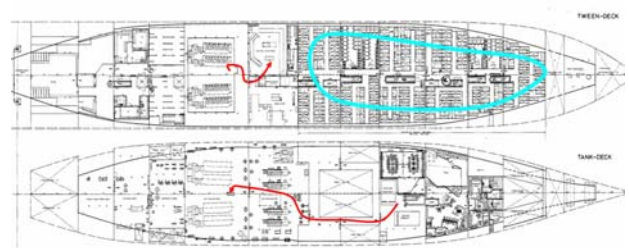
However, according to statements of the three engine room crew, who were present in some 2/3 of the length of the vessel at the very onset of the accident, see Figure 13, no substantial flooding was reported. In total, 22 people from spaces below survived, and none reported any substantial flooding. Hence, any scenario initiating with a breach below the car deck is highly unlikely.

Figure 13 Sketch by the crew (red) and passenger (blue) survivors marking their presence at the initial phase of the vessel foundering. None reports seeing any substantial amount of water in these spaces.

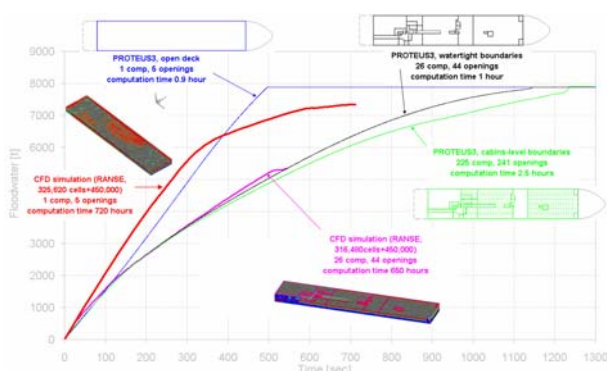
Figure 14 Comparison of the predictions of the process of flooding across Deck 4 in idealised conditions, performed by PROTEUS3 and FLUENT models, [5].

Figure 14 shows that a "decent" degree of detail in representing the internal geometry of the upper spaces is sufficient for representing the flooding process and thus for accurate modelling of the time it took the vessel to capsize. According to results from these simulations the capsizing has never taken more than 2-3 minutes with all the windows assumed broken.

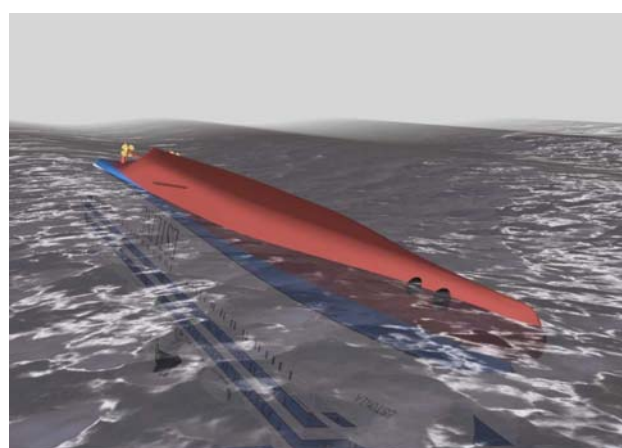
Considering the conditions prevailing at the time, it may in fact be argued that the survivors testimonies support this hypothesis. Namely, 30 survivors claim that MV Estonia sank by stern. However there are 9 survivors who saw MV Estonia sinking by the bow, since they saw the stern, e.g. propellers. It is suggested here that there is no contradiction in these statements and that all of them saw the vessel in an up-side condition.

Figure 15 MV Estonia in an up-side attitude; 30 survivors claim that MV Estonia sank by stern, and 9 survivors state that the vessel sank by bow, with one statement about visible propellers. Could all these survivors have seen MV Estonia floating bottom-up?

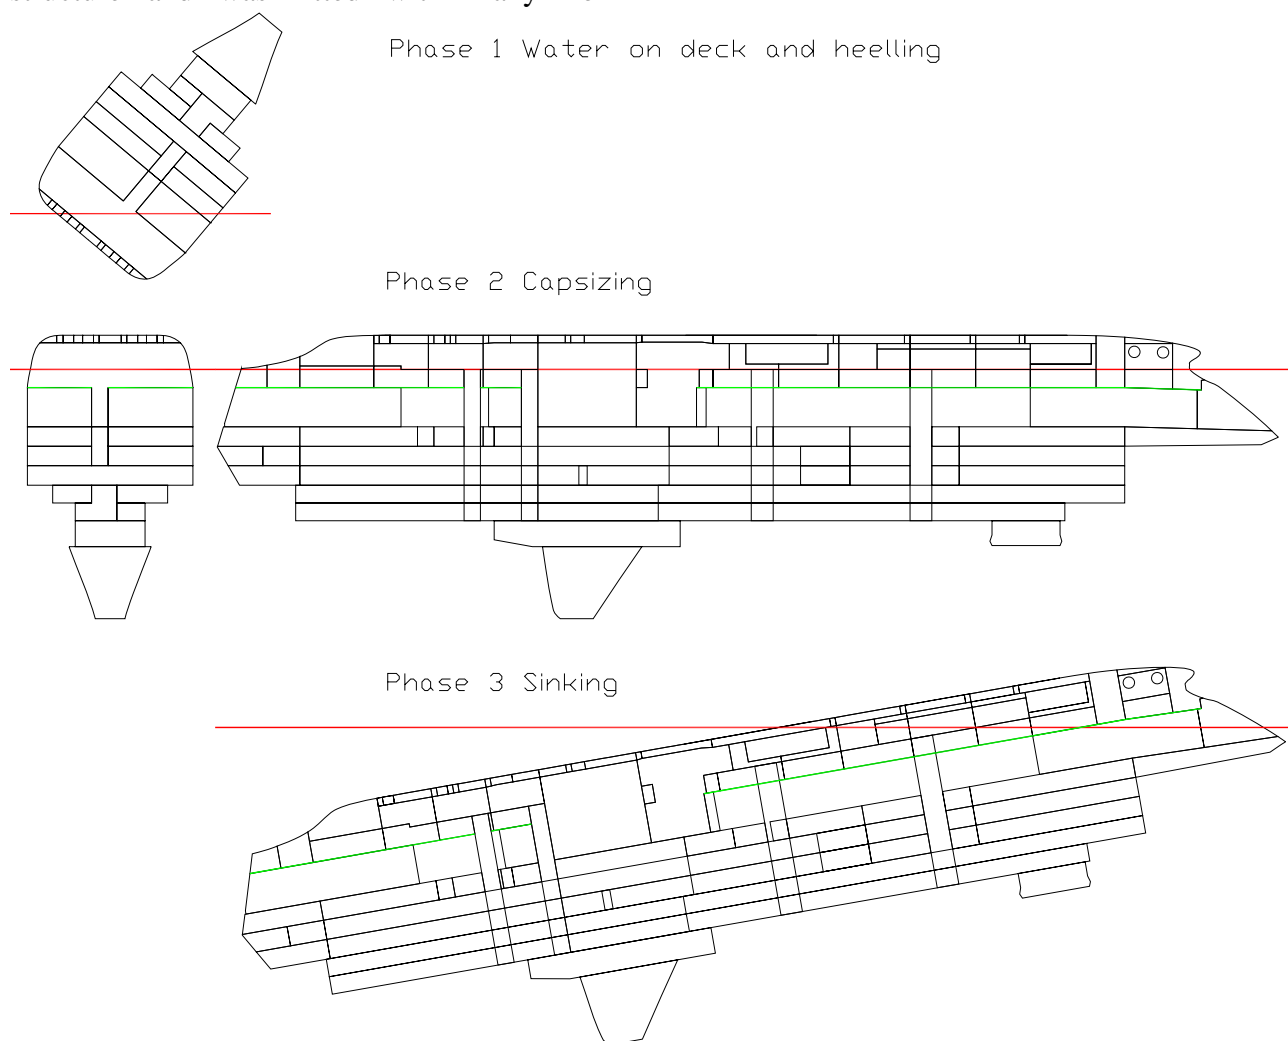
Figure 16 A likely loss sequence of the loss of MV Estonia. Flooding of the spaces below the car deck commenced once MV Estonia capsized. The multitude of doors in the centre casing collapsed due to excessive water head pressure of 2 to 8 m. Some **2 m²** of opening in the centre casing would be sufficient to allow for 10,792 m³ of water to enter the spaces below the car deck within 15-18 minutes.

As is shown in Figure 16, the sinking sequence can be broken into three phases.

(1) Firstly, water accumulation on the car deck took place. It must have started relatively rapidly with the vessel heeling to high angles

(2) Secondly, once the amount of some 2,500m³ accumulated on the car deck the vessel capsized, that is, it turned up-side down, within some 3-4 minutes. It is suggested here that 3-4 minutes would be sufficient for many to remember the vessel to have been at 90deg+ attitude “for some time”.

(3) Thirdly, the sinking would commence as described above, through the submerged centre casing.

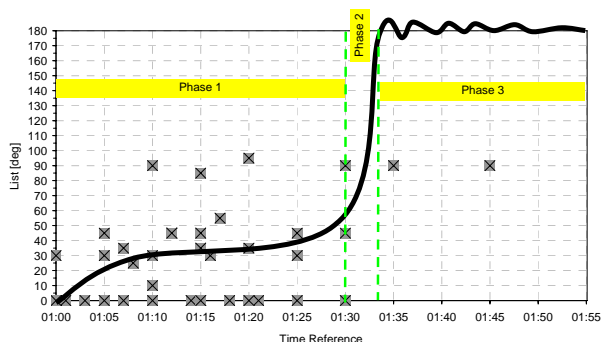
On average, the water inflow between 01:00 and about 01:30 must have been in the order of some 83 m³/min.

Figure 17 Could it be that heeling, capsizing and sinking followed such trend? Some 83 m³/min on average have flooded into the car deck between 01:00 and 01:30. Capsizing would take place in some 3-4 minutes. As the vessel turned turtle, all spaces from a height of 7.65 m upwards fill up with water at a rate of some 15,000 m³/min through many broken windows. Finally, at 01:34 water starts flooding the spaces “below” the car deck (now up) at some 600 m³/min through the centre casing. In total, over 72,106 m³ of water enters MV Estonia between 01:00 and 01:52.

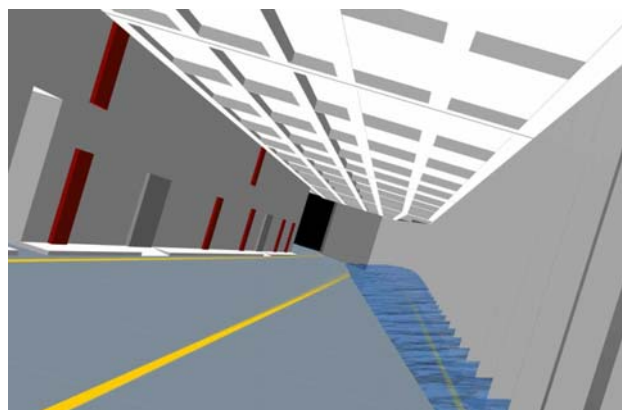
If the ship did float up-side down, then the centre casing becomes submerged some 2 to 8m below the free surface and hence is subject to considerable pressure. Since the design of the centre casing was only as a fire-resistant structure and was fitted with many non-

watertight doors, see Figure 18, it is highly likely that it would break and let water into the spaces “below” the car deck. In fact, at a water head pressure of 5m and an opening of 2m² (1 door), the amount that could flood into these spaces in 15-18 minutes would be sufficient for the vessel to sink, see Figure 5.

Figure 18 The centre casing was fitted with many fire doors. In an up-side down attitude the centre casing is some 5m below the sea surface, hence it would buckle under pressure and let water reach spaces “below” the car deck.
