New Insights on the Sinking of MV Estonia

ABSTRACT

MV Estonia, Forensic Study, Damaged Ship Stability, Time to Capsize

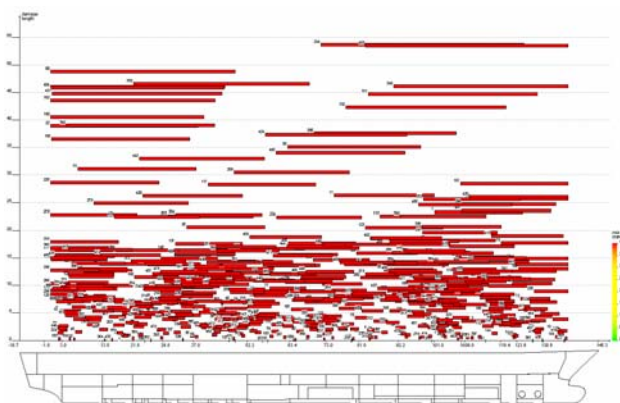
A study has been undertaken to investigate the possibility of larger angles of heel occurring due to transient flooding effects. The study has comprised a series of numerical simulations of the vessel response when subject to damages below the car deck occurring randomly according to historical data on collisions, see Figure 7.

Figure 7 Sample MC simulations set-up, distribution of damage location, length and Hs. Damages assumed below the car deck.

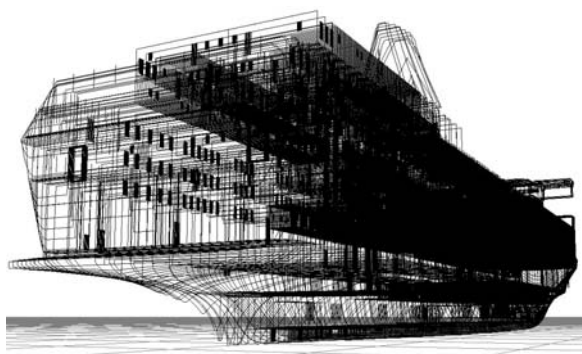
A model of MV Estonia, Figure 8, has been subjected to these damages, Figure 9, and a statistic derived of the maximum heel angles recorded during the initial stages of flooding, as shown in Figure 10.

Figure 8 Digital model of MV Estonia, aft and front views, PROTEUS3.

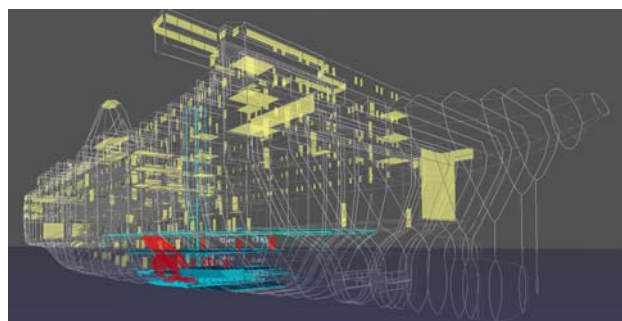
Figure 9 A sample snapshot of the simulation of flooding below the car deck.
